GENERAL STRUCTURAL REVIEW

**Of fire damage to existing house at 114 Keith Street,
Whitby, Ontario,**

June 13th, 2024

Project: - **General Structural review**
Collapsing wood framing and cracking foundation walls etc.

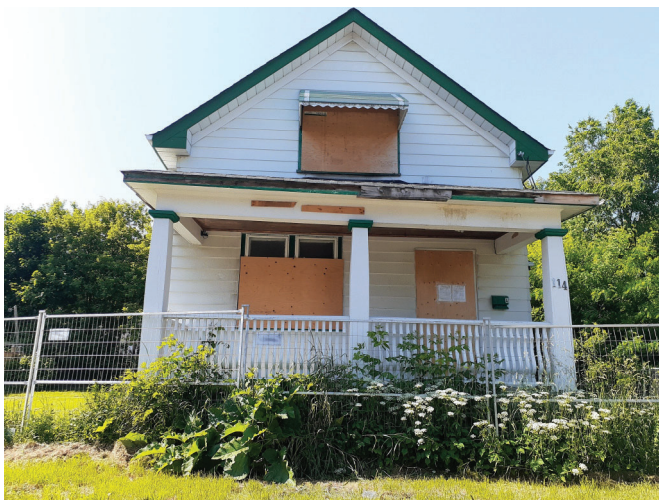
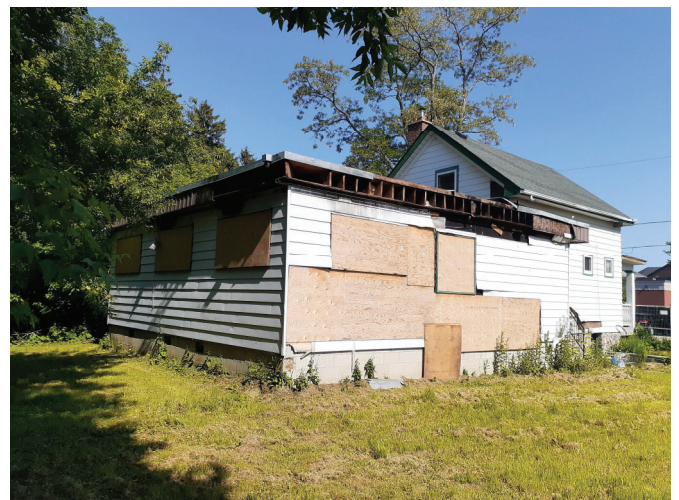
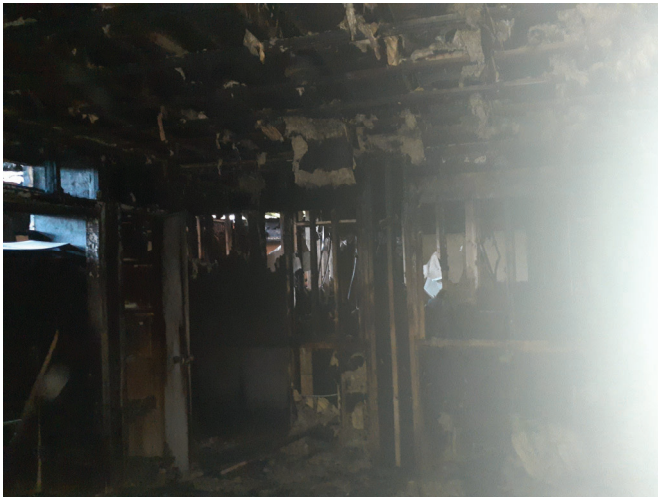
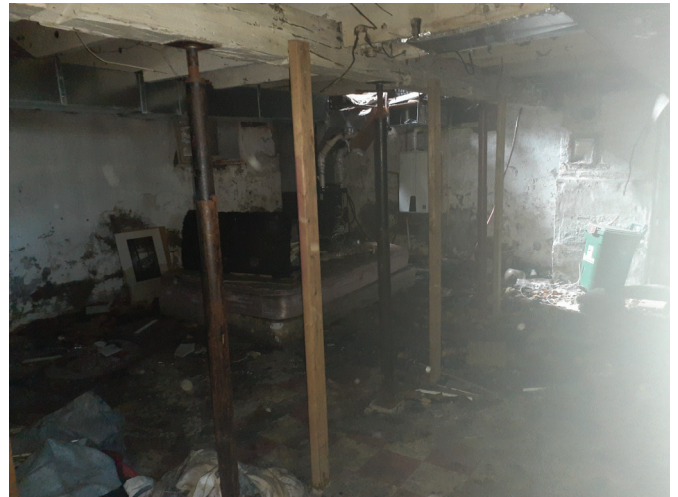
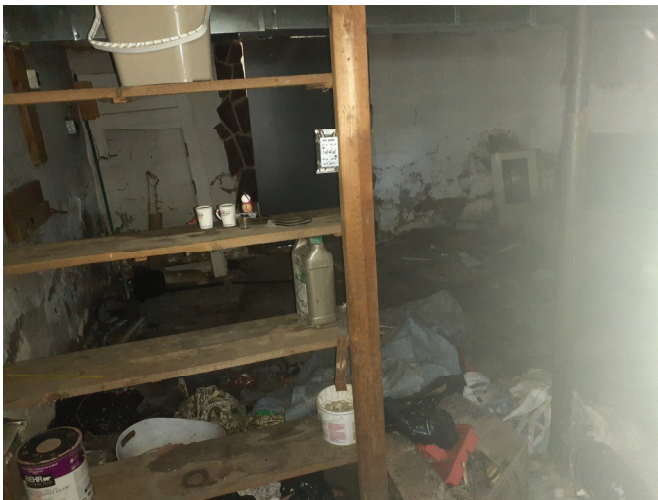
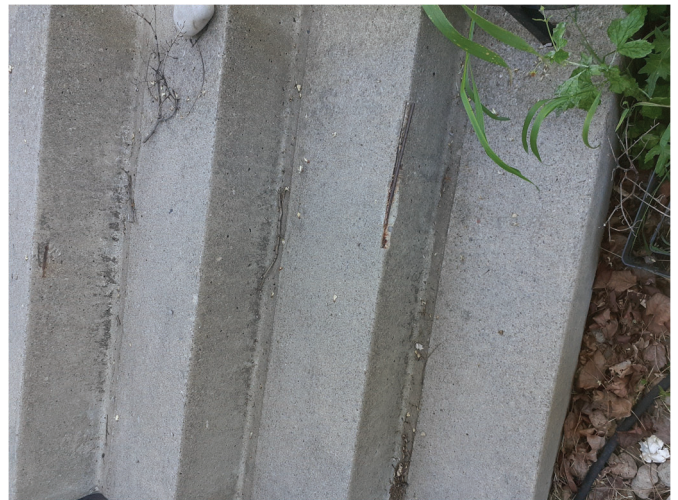
As per your request we have performed a site visit of the property located at 114 Keith Street, Whitby, Ontario on June 12th, 2024. The property consists of a 1.5-storey residential facility with semi-finished basement and a single-storey with crawl space at rear side. We were informed that there was a fire incident, a year from now, at the rear side. When we visited the site, we visually noticed that the rear side floor and flat roof framing was severely burnt, and it is not even safe to walk through and inspect. We could still smell the burning smoke and char etc. The fire damage at rear side is very extensive and we have never seen such lateral / horizontal extension of fire or in other words fire encapsulating such larger area. We do these kinds of inspections and usually the fire damage is one vertical shaft, above fire source location and from that level up everything is gutted. The second-floor front side and roof seems intact. However, the framing structure at the joint with rear side is severely burnt and may collapse any time. Furthermore, as the house is left unattended, unoccupied and unheated during recent winters, seems like frost heave has taken toll on it. We do see, visually; some vertical and horizontal misalignments in building superstructure from outside, cracking of existing foundation walls and spalling with exposed rebars of concrete stairs etc. The broken window glass makes it even worse by letting cold air roam in and out of the house. Please see pictures below for reference.

In our opinion, based on our visual observations during our site visit, the interior side show excessive sign of burning and section loss in roof, walls and floors of rear side and at joint with front side. The front side has been showing excessive damage due to winter exposure. The heat due to fire in the rear side already took toll on it and weakened its framing and had less redundancy to withstand cold temperatures. The exterior side shows cracking, spalling, misalignments, bowing and sagging etc. There is no point salvaging any portion and we recommend taking down the entire residential facility in entirety. If needed, a new facility shall be built from scratch. We have advised adding cautionary tape around the property and putting bold signs at main door / front elevation exhibiting danger etc. Also to inform all adjacent neighbours to practice caution and stay away from the party / common area. They may consider relocating until this house is safely demolished.

THE FACILITY SHALL BE TOTALLY CORDON OFF / ISOLATED WITH IMMEDIATE EFFECTS. A QUALIFIED, FULLY INSURED, LICENSED AND EXPERIENCED DEMOLITION COMPANY SHALL BE HIRED AND THE SUPERSTRUCTURE SHALL BE REMOVED IMMEDIATELY. THE SUB STRUCTURE CAN BE DONE AT A LATER STAGE SO FAR THE NEWLY FORM DITCH IS ABSOLUTELY PROTECTED FROM ANYONE'S ACCESS. IN OUR OPINION THIS IS THE ONLY SAFE SOLUTION.
