Cultural Heritage Impact Assessment Report

407 & Garrard Road, Whitby ON

June 2023

Garrard Investments Inc.

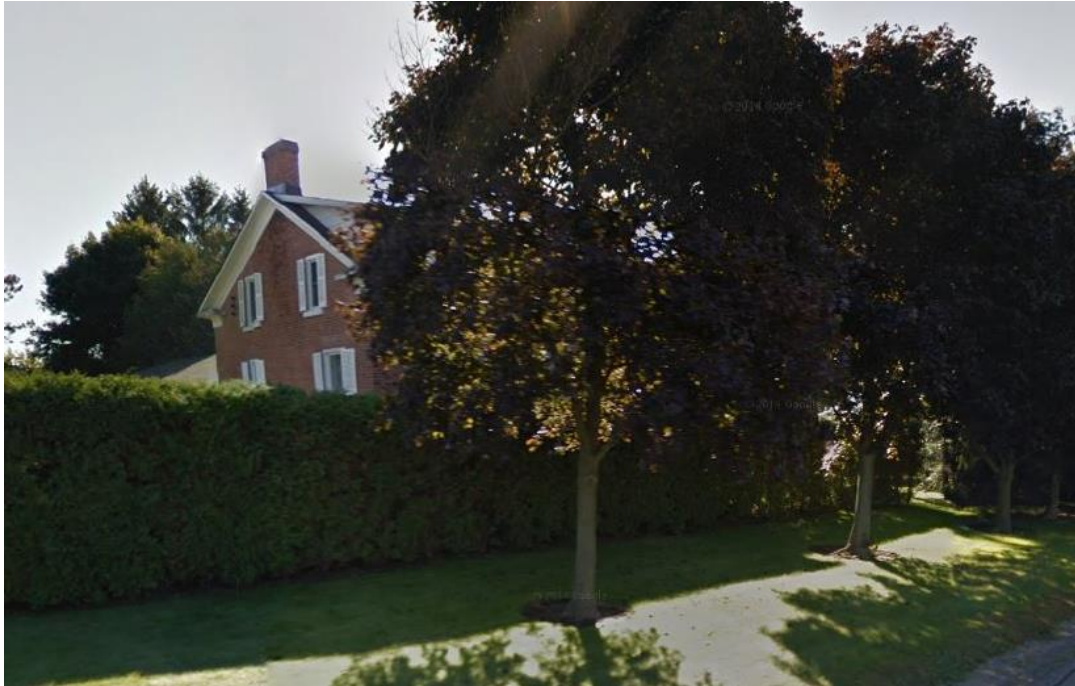
Figure 2: Photograph of the property at 5515 Garrard Road included in the Town of Whitby Property of Cultural Heritage Value or Interest summary (no date) (Source: Town of Whitby Planning, attached to Record of Pre-Consultation dated February 25 2022)

5515 Garrard Road was built in circa 1855. The property features a house, barn and farm out-buildings. The red brick house is a one-and-a-half storey side gable and is rectangular in plan with a rear wing. The front façade is symmetrical with a centre door with windows on either side. The side elevations are symmetrical with two bays and two windows on each storey with shutters. There is a chimney in the gable end. The property was originally owned by Daniel Lamond who initially purchased fifty acres from Thomas Moore in 1834, and then purchased an additional twenty-five acres in 1837. In 1917, Margaret Lamond sold 75 acres to Robert J. Ellerington.

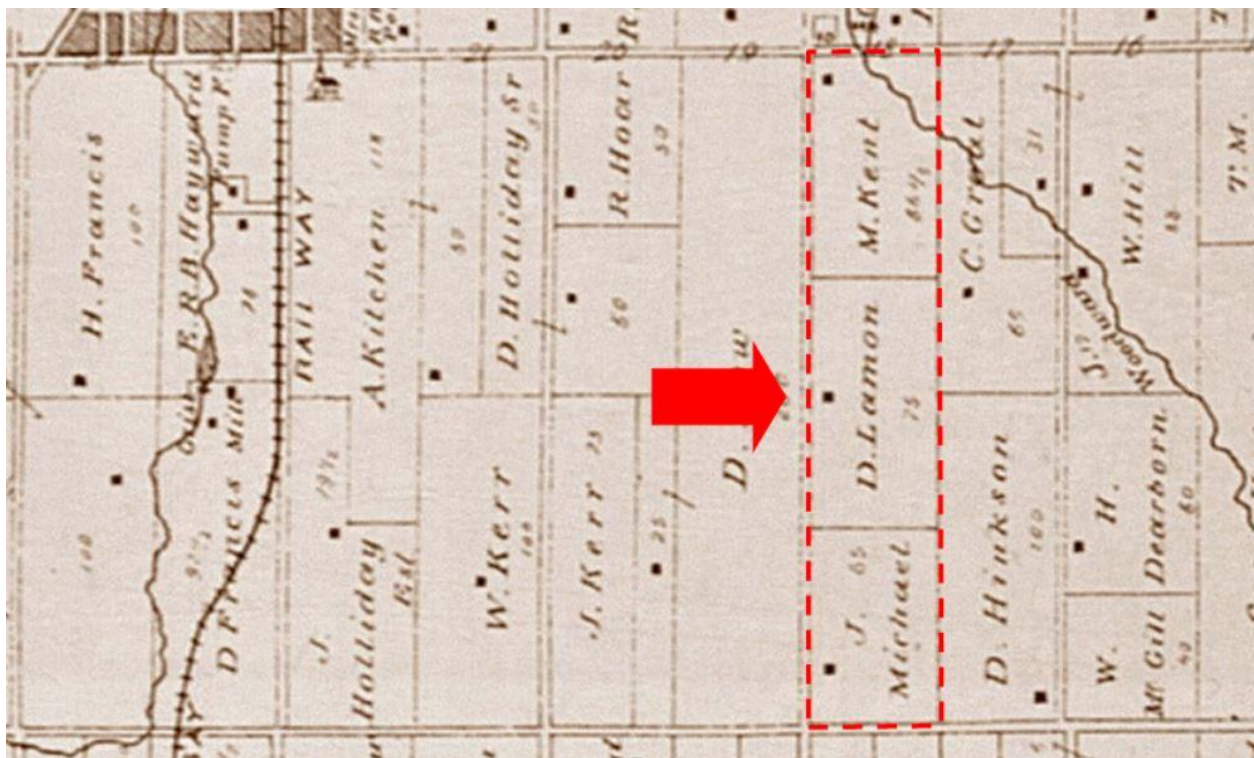
Figure 8: Excerpt of the 1877 Illustrated County Map of Ontario County. Location of all of lot 18, Concession 5 outlined with red dashed line. (Source: University of Toronto)

Daniel Lamon is also noted on the 1877 Illustrated map of Ontario County. He is noted as residing on a 75 acre lot. The map notes the farmstead/dwelling in the same location as the Tremaine map.

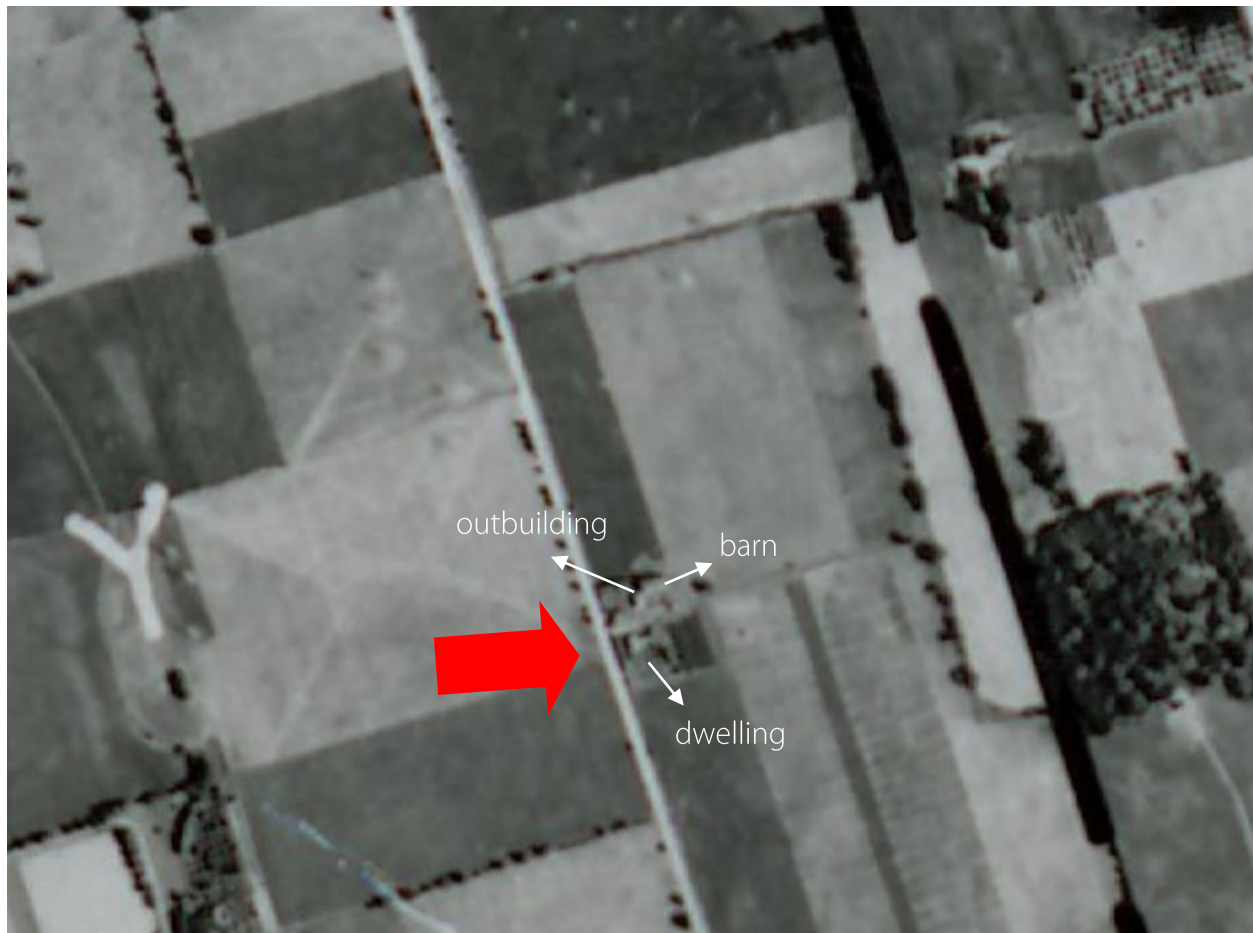
Figure 11: 1954 aerial photograph of the subject property and adjacent listed property at 5515 Garrard Road (Source: University of Toronto Map and Data Library, accessed 2023)

The 1954 aerial photo shows the location of a dwelling, as well as the existing barn and outbuilding and orientation of the fields (See Figure 11). The contemporary rear addition has not yet been constructed. The property does not include the landscaped open space with mature trees which currently exist.

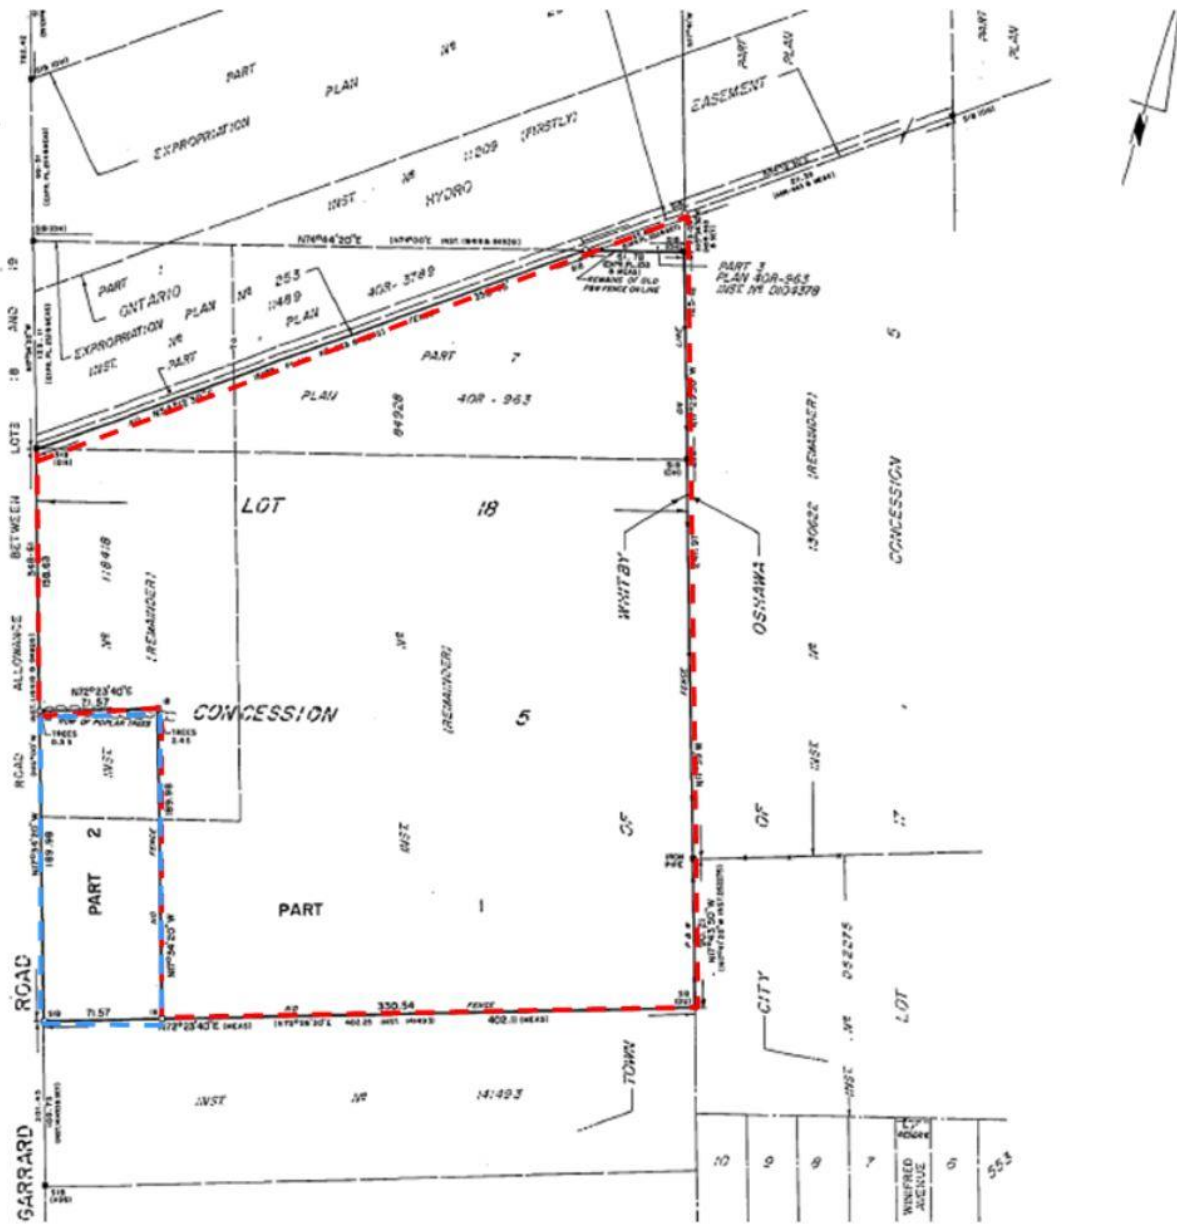
Figure 12: Excerpt of Plan 4-r13544. Approximate location of the property at 5515 Garrard Road outlined with blue dashed line. Remaining portion of the subject lands outlined with red dashed line. (Source: Onland.ca, accessed 2023)

The property at 5515 Garrard Road was severed in 1992 and became Part 1 of Plan 40r13544. The property at 5515 Garrard Road became Part 2. Therefore, the original 75 acre Lamon farmstead was separated from the surrounding agricultural fields in 1992. Members of the Torok family continue to own the property at 5515 Garrard Road.

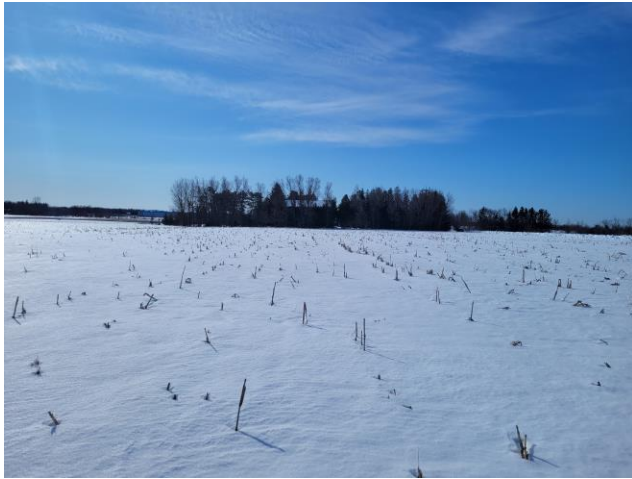
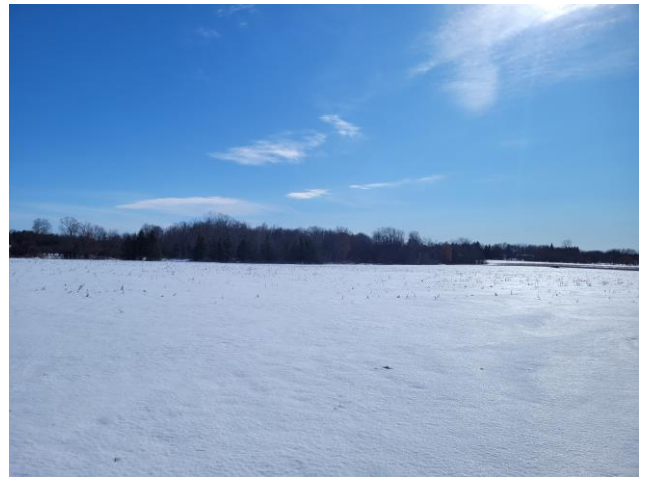
Figures 19 & 20: (left) View of the subject lands, looking south towards 5515 Garrard Road, Garrard (right) View of the subject lands looking east towards a naturalized/wooded area (Source: MHBC, 2023).

The portion of the subject lands legally described as Part Lot 18, Con 5 Township of Whitby Pt 40r13544, Town of Whitby includes agricultural fields. No buildings or structures are located on this portion of the subject lands. A portion of a naturalized/wooded area along the east property line.

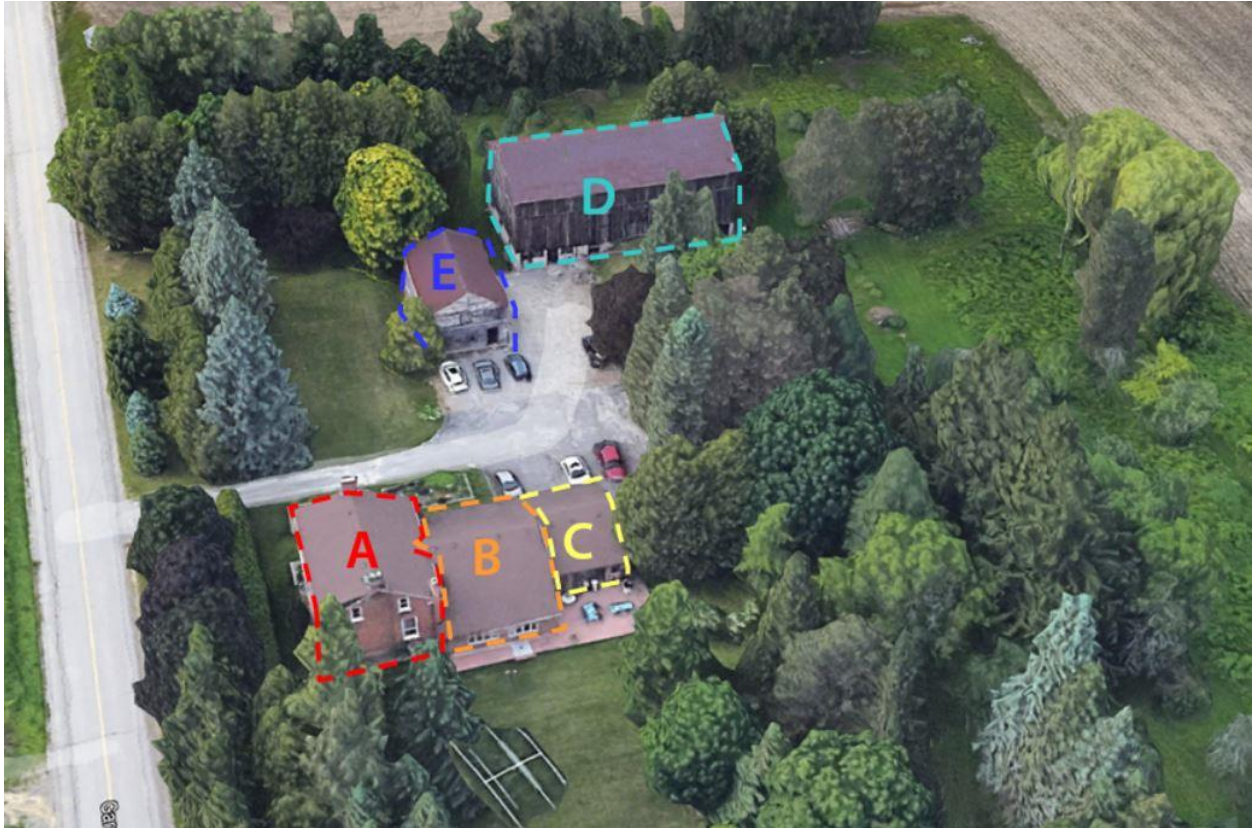
The main portion of the dwelling (described below as Section “A”) was constructed at some point between 1834 when the property was sold to Daniel Lamon, and 1861 when evidence of the building appears on the 1861 Tremaine map of Ontario County. The dwelling includes two contemporary additions, described in this report as Sections “B” and “C”. There is evidence to suggest that the original dwelling was located east of Section “A” and has been removed to construct Section “B”. The property includes a large wood frame bank barn of 19th century construction (Building “D”), as well as a 19th century wood frame outbuilding (Building “E”).

Figure 21: 3-D aerial view of the adjacent property at 5515 Garrard Road (Source: Google EarthPro, accessed 2023).

Identifier	Date of Construction	Notes
A	Bet. 1834 and 1861	1 ½ storey brick dwelling
B	1979	Contemporary addition
C	1979/late 20 th century	Single storey garage
D	Bet. 1834 and 1861	Wood frame bank style barn
E	Bet. 1834 and 1861	Outbuilding (unknown purpose)

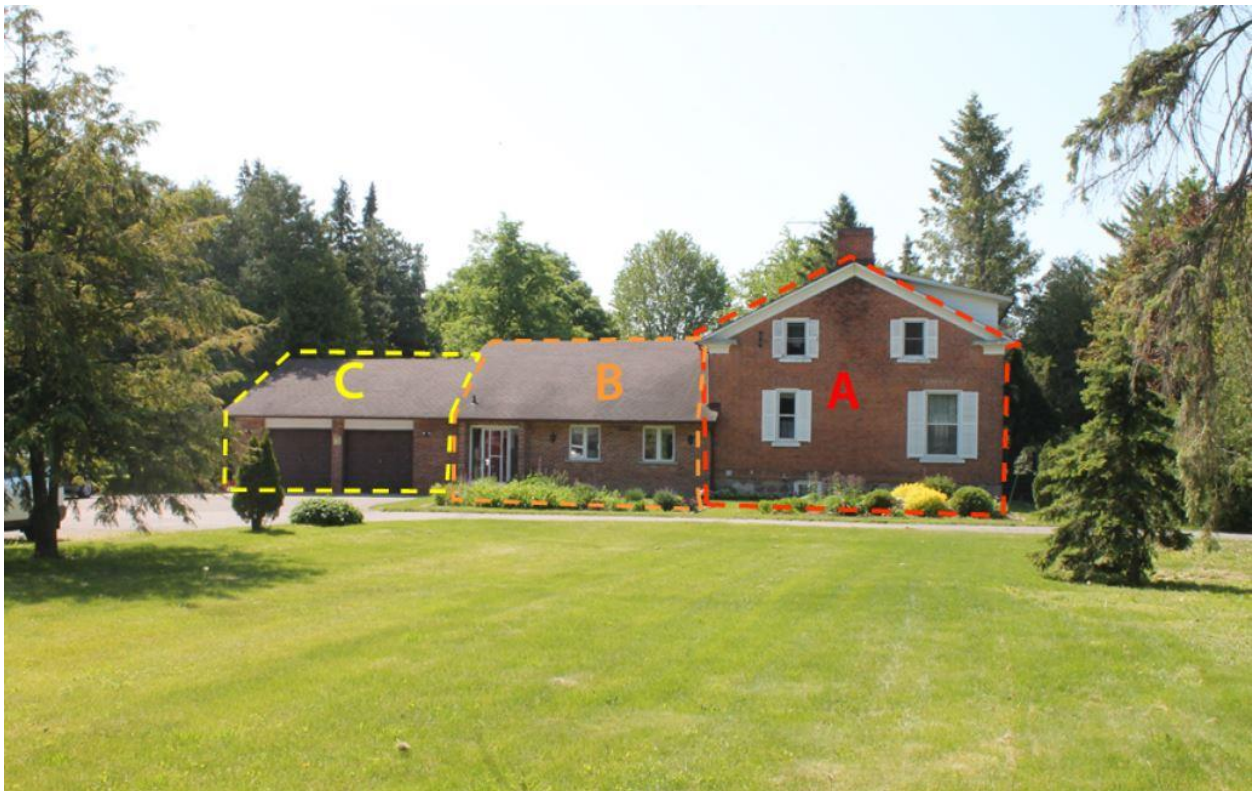
The operational shutters as well as the dormer window addition at the front elevation are not original to the structure (See Figures 22 & 23). All original windows have been replaced. The basement windows are wood framed but are likely not original to the structure are likely from the early to mid. 20th century given the quality of the window panes and hardware.

Figure 22: View of Sections “A”, “B” and “C” of the dwelling, looking south (MHBC, 2023)

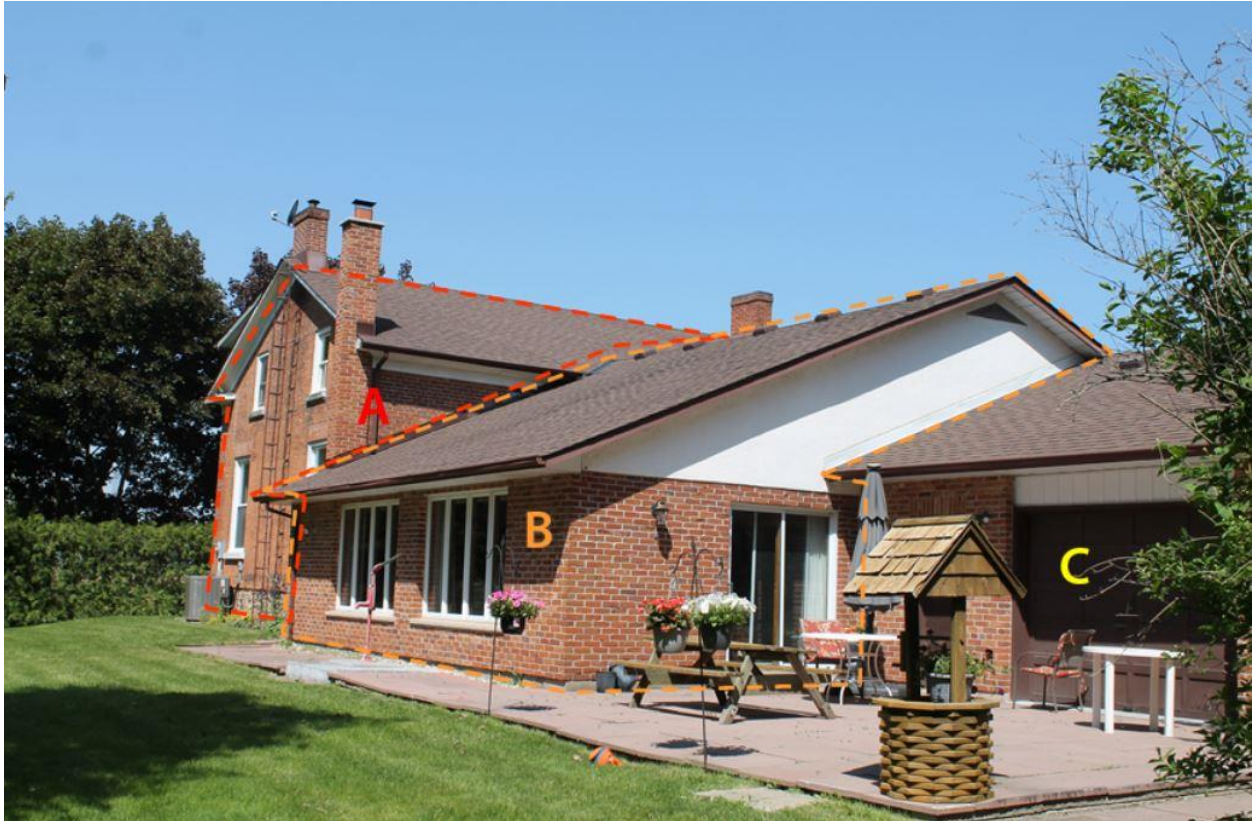
Figure 23: View of Sections “A”, “B” and “C” of the dwelling, looking west towards Garrard Road (MHBC, 2023)

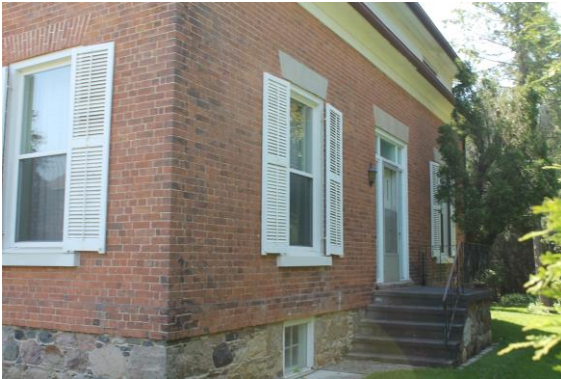
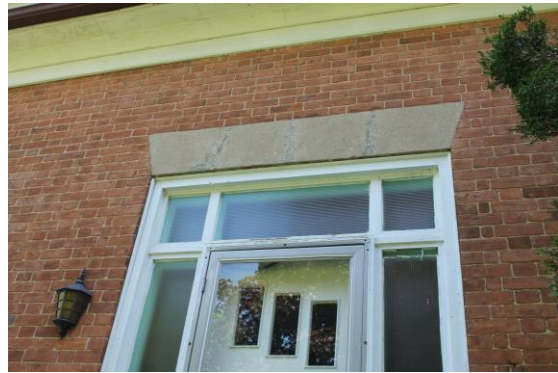
The front elevation of Section “A” includes a 3-bay façade with a central entrance. The original front door as well as the original sidelights, transom, and wood framing have all been removed and replaced. The front façade includes the original concrete lintels above windows and doors. All other facades of the building include brick voussoirs. The majority of sills have been encased in aluminum. The remaining sills within Section “A” of the building are constructed of wood.

Figures 24 & 25: (left) View of the front elevation of the dwelling (Section "A"), (right) Detail view of the main entrance of the front elevation of the dwelling, (MHBC, 2023)

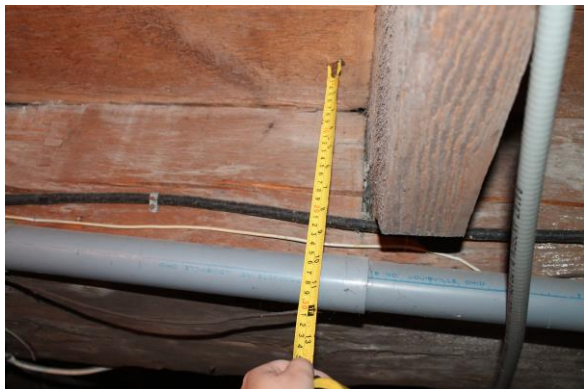
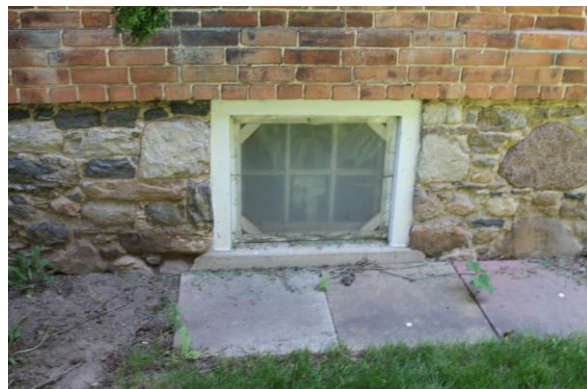
An inspection of the interior of the building confirmed that the building was constructed with mid. 19th century construction materials and techniques. The house is constructed with a field stone foundation (See Figure 27). The building includes two hand hewn beams with sawn floor joists which are notched into the beams (See Figure 26).

Figures 26 & 27: (left) View of hand hewn beam and sawn floor joist, (right) Detail view of the main entrance of the front elevation of the dwelling, (MHBC, 2023)

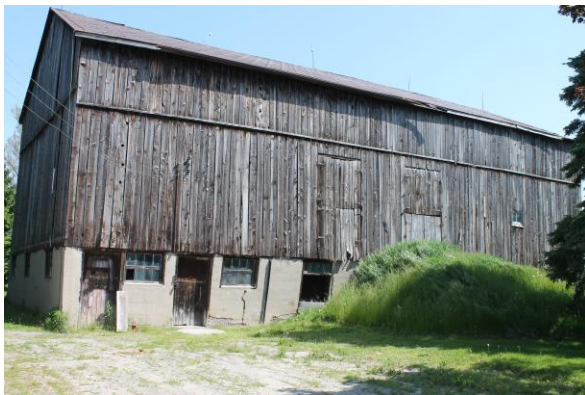
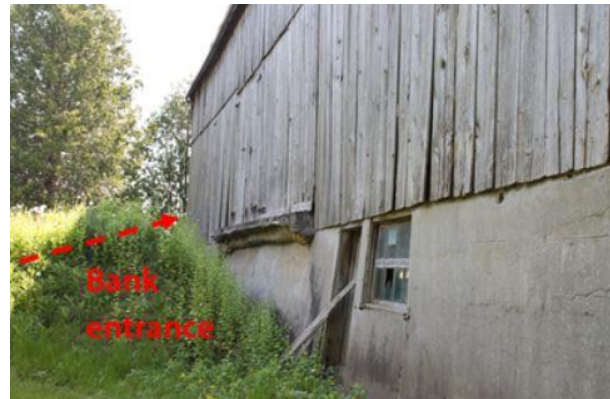
The barn located on the property at 5515 Garrard Road can be described as a wood-frame bank barn with a concrete foundation. The raised bank and barn doors are located at the north elevation. The date of construction of the barn can not conclusively be determined with the historic records which are currently available, but was likely constructed at some point between 1834 and 1861.

The barn was constructed with materials and construction techniques typical of the mid. 19th century, including hand-hewn logs which are notched into hand-hewn structural beams. The barn includes the use of mortise and tenon joints, wood pegs, and machine-cut nails. The existing concrete foundation is likely not original to the structure. The barn was likely constructed with a fieldstone foundation, which has since been replaced with poured concrete and made to look like concrete blocks. No fieldstones were present within the foundation which would suggest that an original foundation had been parged.

Figures 28 & 29: (left) View of the south elevation of the barn, looking north (right) View of the north elevation of the barn looking south-east, (Source: MHBC, 2023).

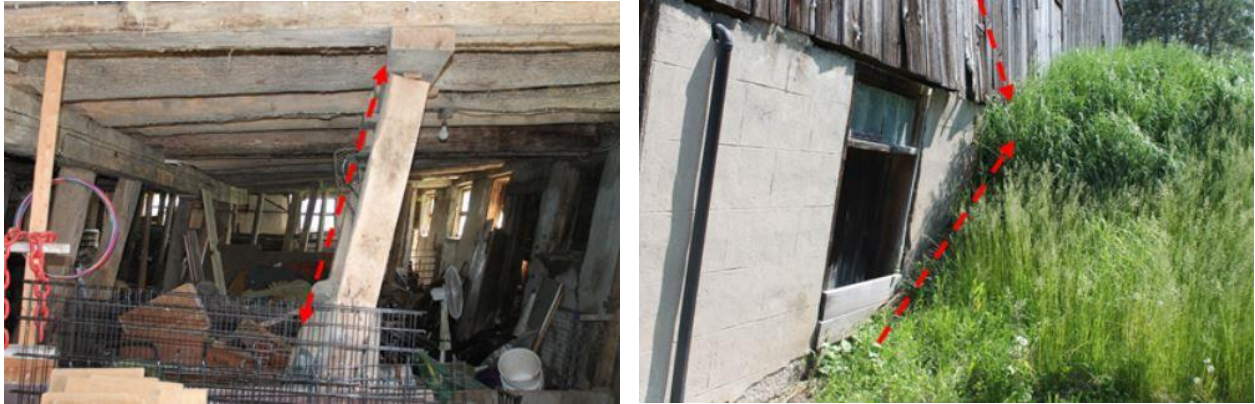
The condition of the barn was observed as poor. The structural supports of the barn are significantly bowed to the south and is currently resting upon a pile of fill at the south elevation which has (in part) is preventing collapse (See Figures 30 & 31).

Figures 30 & 31: (left) View of the interior structural supports of the barn, looking east, (right) View of the south elevation noting the bowed foundation resting upon a pile of fill (Source: MHBC, 2023).

This option includes developing the subject lands for industrial use while retaining the barn and dwelling in-situ. This leads to difficulties in configuring a site plan given the locations of both the dwelling and barn. It is unlikely that a sizeable industrial building could be developed while leaving the buildings in-situ. This option may include removing the barn, and leaving the dwelling in-situ. This option may also result in difficulties configuring a site plan which incorporates both new industrial buildings and the existing dwelling. Further, the condition of the barn is poor and displays evidence of structural issues. It is unknown whether or not the barn could be retained due to its current structural instability.

Either option would require pre-determination that the structures would be able to withstand the physical act of re-location. If this option is considered, a structural condition assessment would be required from a structural engineer, preferably an engineer with demonstrated experience in heritage buildings. The re-location of the barn may require dis-assembly and re-assembly due to its size and condition.

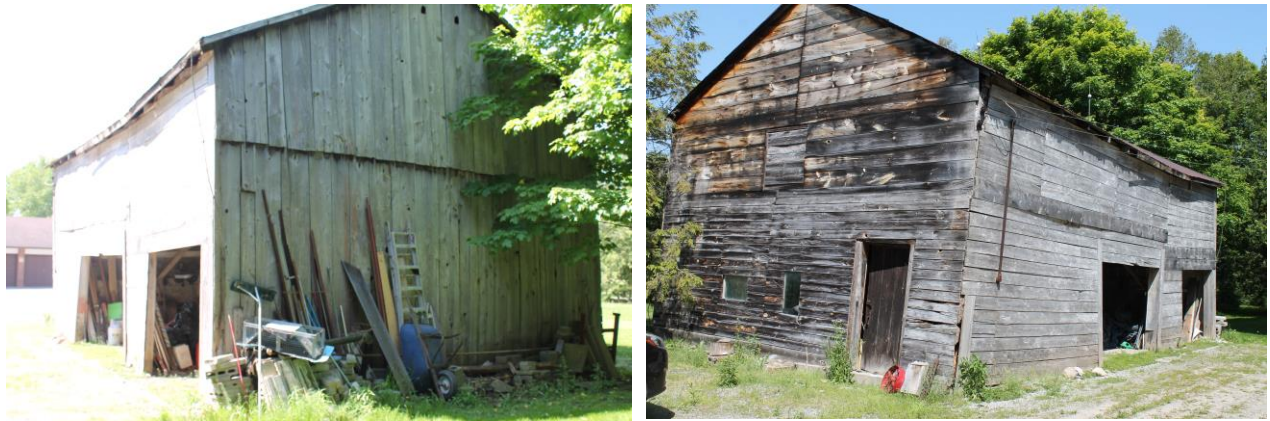
The outbuilding was constructed with materials and construction techniques typical of the mid-19th century, including hand-hewn logs which are notched into hand-hewn structural beams. The barn includes the use of mortise and tenon joins, wood pegs, and machine-cut nails. The use of the outbuilding is unknown, but was likely ancillary to the former farming operations of the property. The outbuilding also shows evidence of 19th century replacement of some structural elements, including roof framing. The exterior of the outbuilding at the east, west, and south elevation are likely 20th century replacement boards. However, the presence of cut nails at the north elevation suggests that the exterior cladding at this location may be original.

Figures 32 & 33: (left) View of the north and east elevations, looking south-west, (right) View of the south and east elevations, looking north-west (Source: MHBC, 2023).

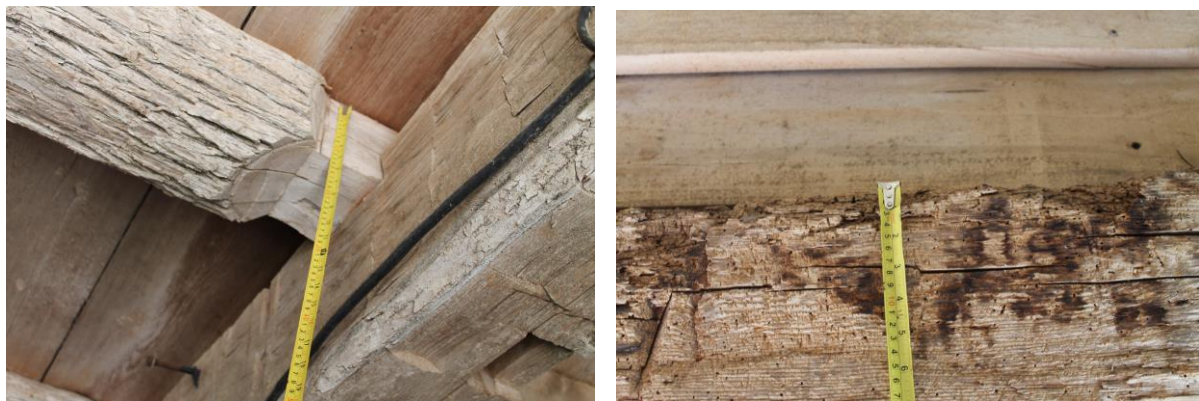
There was observable damage to the structural elements due to termites, as well as powderpost beetle (See Figure 35).

Figures 34 & 35: (left) Detail view of interior framing, including notched logs and hand hewn beams, (right) View of the interior framing, noting terminate and/or powder post beetle evidence, (Source: MHBC, 2023).

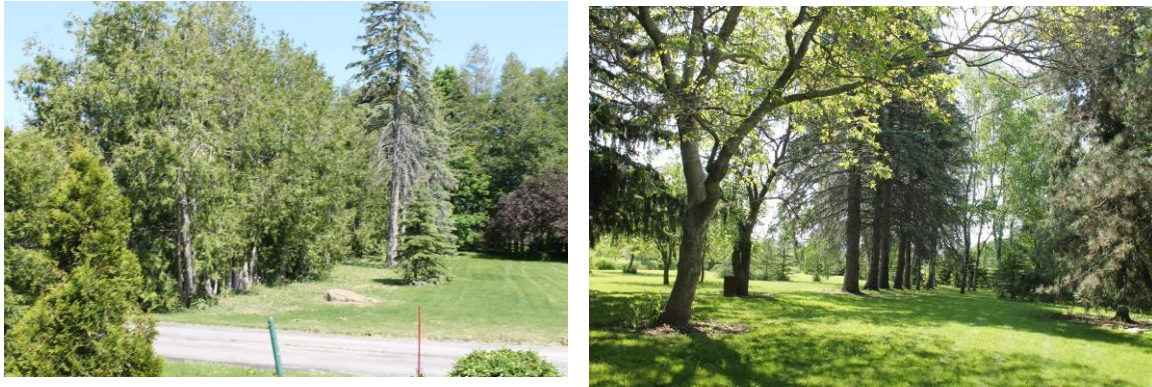
Figures 36 & 37: (left) View of linear plantings located along the west (front) property line, (right) View of linear plantings and landscaped open space at the interior of the lot, (Source: MHBC, 2023).

The subject property includes linear plantings of both deciduous and coniferous trees along the west (front) and north property lines (See Figure 36). The subject property includes landscaped open space and mature trees. A comparison between the 1954 aerial photograph and oral evidence from the existing property owners, the existing trees on the property were planted after the property was purchased by the Torok family.
