Town of Whitby

Designation of the Mayfield House, 780 Garden Street as being of Cultural Heritage Value and Interest

SCHEDULE 'B'
TO
BY-LAW NO. XXXX-23

DESCRIPTION OF PROPERTY – 780 Garden Street

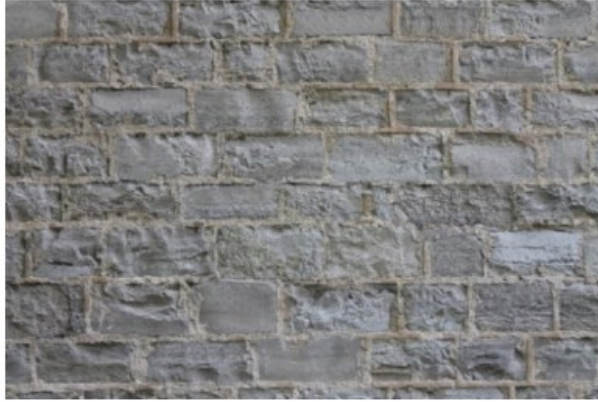
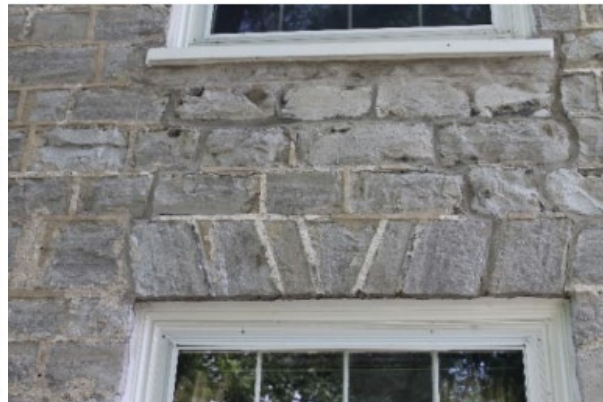
The West Elevation of the Mayfield House overlooks Mayfield Crescent and has a gabled end with a stone chimney and a projecting eave with eave returns. There are two pairs of symmetrical windows, two on the ground floor and two on the second floor. The double-hung windows are generously scaled, with 8-over-8 sashes, and stone flat arches. On each gabled end there is a quarter fanlight window with two rows of five glass panes. The addition constructed in the 1990s on the North Elevation is visible from the west view and has an L-shaped layout.

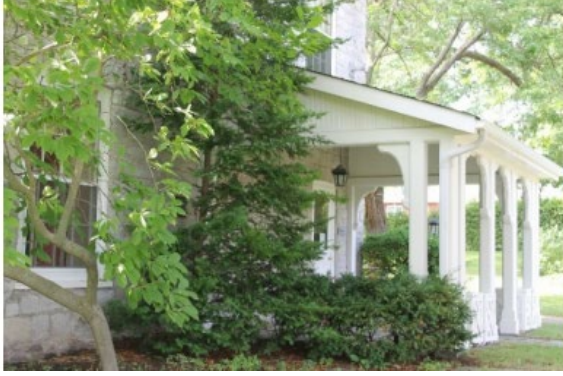
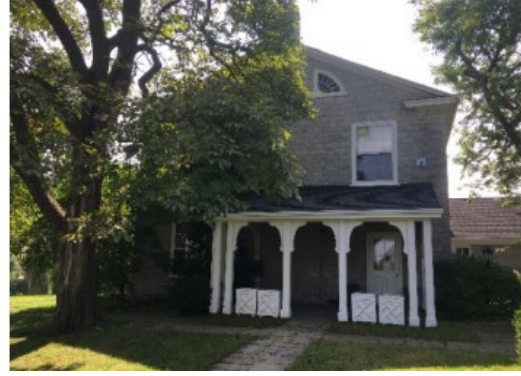
The East Elevation overlooks Garden Street and has a similar layout as the West Elevation except for the exterior door replacing the lower-right window. The non-original door consists of four-panels in which the upper two are glazed, and has an original arch opening. A porch was constructed on the elevation underneath the upper windows with asphalt shingle cladding and equally spanned pairs of columns. The porch forms an informal entry that leads to the kitchen and has minimal impact on the heritage attributes of the house. The porch was formerly constructed with screen mesh and light framing however was modified into the current design comprising pairs of posts with brackets.

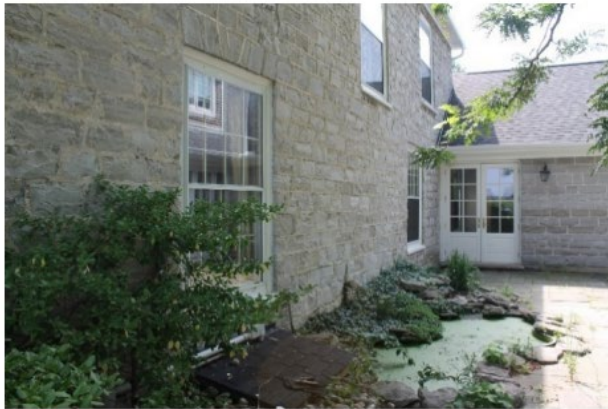
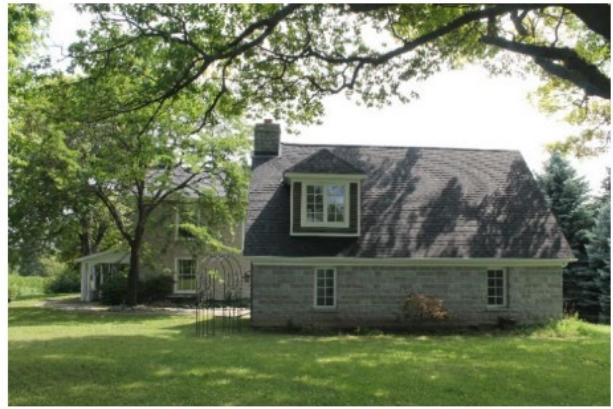
The North Elevation has an addition at its west end, and, in its original stone façade, contains five window openings, three on the second storey and two on the ground floor. The lower windows are double hung, have stone arch lintels and wooden sills with 8-over-8 sashes. The first and third upper windows are identical to the lower ones while the middle window has 12-pane over 8-pane sashes. Connected to the North Elevation is an additional structure that was constructed approximately 20 years ago. Currently the addition is being used as office space with a meeting room on the upper floor and desk space on the ground floor. The roof is clad with asphalt shingles while the walls are constructed from stone masonry.

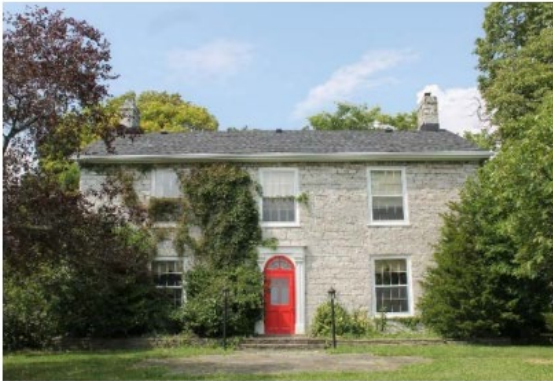
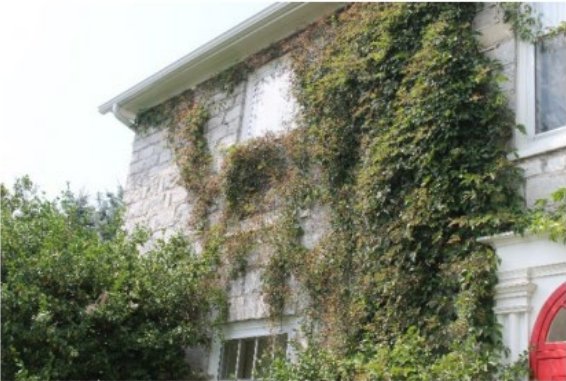
The South Elevation is an indication of the principal and original orientation of the dwelling and forms the main view of the house. There are five identical window types, three upper and two on the lower storey. The elevation is perfectly symmetrical with a centered original exterior door. The windows are double hung with stone arch lintels and 8-over-8 sashes. The exterior door has been painted red sometime after 1983 along with modifications being made to the frame. The arched fanlight has four pane segments with thick glazing bars while the fanlight behind the recess has five pane segments and thin glazing bars. There are creeping vines on the left (west) side of the wall reaching up to the roof. Creeping vines can cause moisture problems in the wall

assemblies and loosen up the stone mortar joints and they should be removed as part of regular maintenance.
